Manhole Inspection Summary

Manhole # S37A__017MH

Insp Date: **9/18/08 1:58 PM**

Location Address: **side of 500 the fallsway**

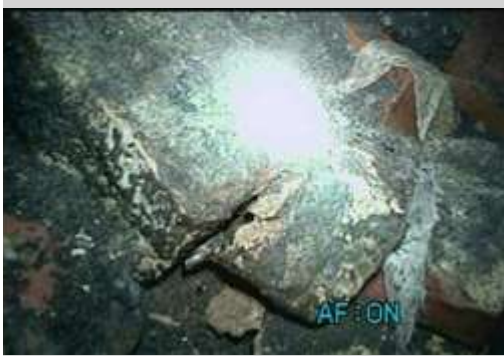
Defect 3

Condition: ☐ Sound ☐ Cracked ☐ Root Intrusion ☐ Deteriorated ☐ Leaks ☒ Debris

bench debris

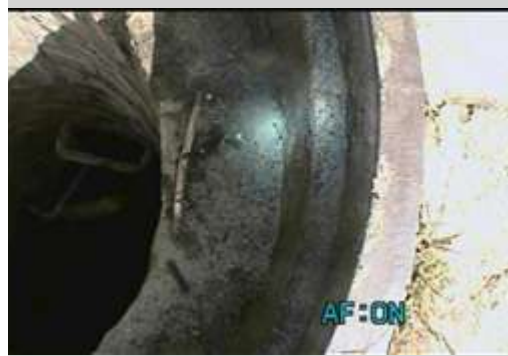
Defect 2

Offset: **4.5** (in.)

offset

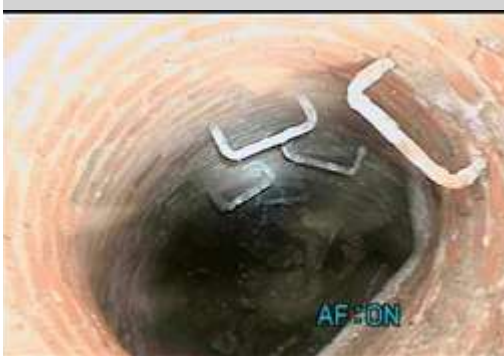
Defect 1

Count: **5** Missing: **0** ☒ Corroded

cor. steps
